# Guam Waterworks Authority (VP0989)

## CWA Collection System

Tumon, Guam

NEIC Field Investigation Photographs  
April 24 through May 4

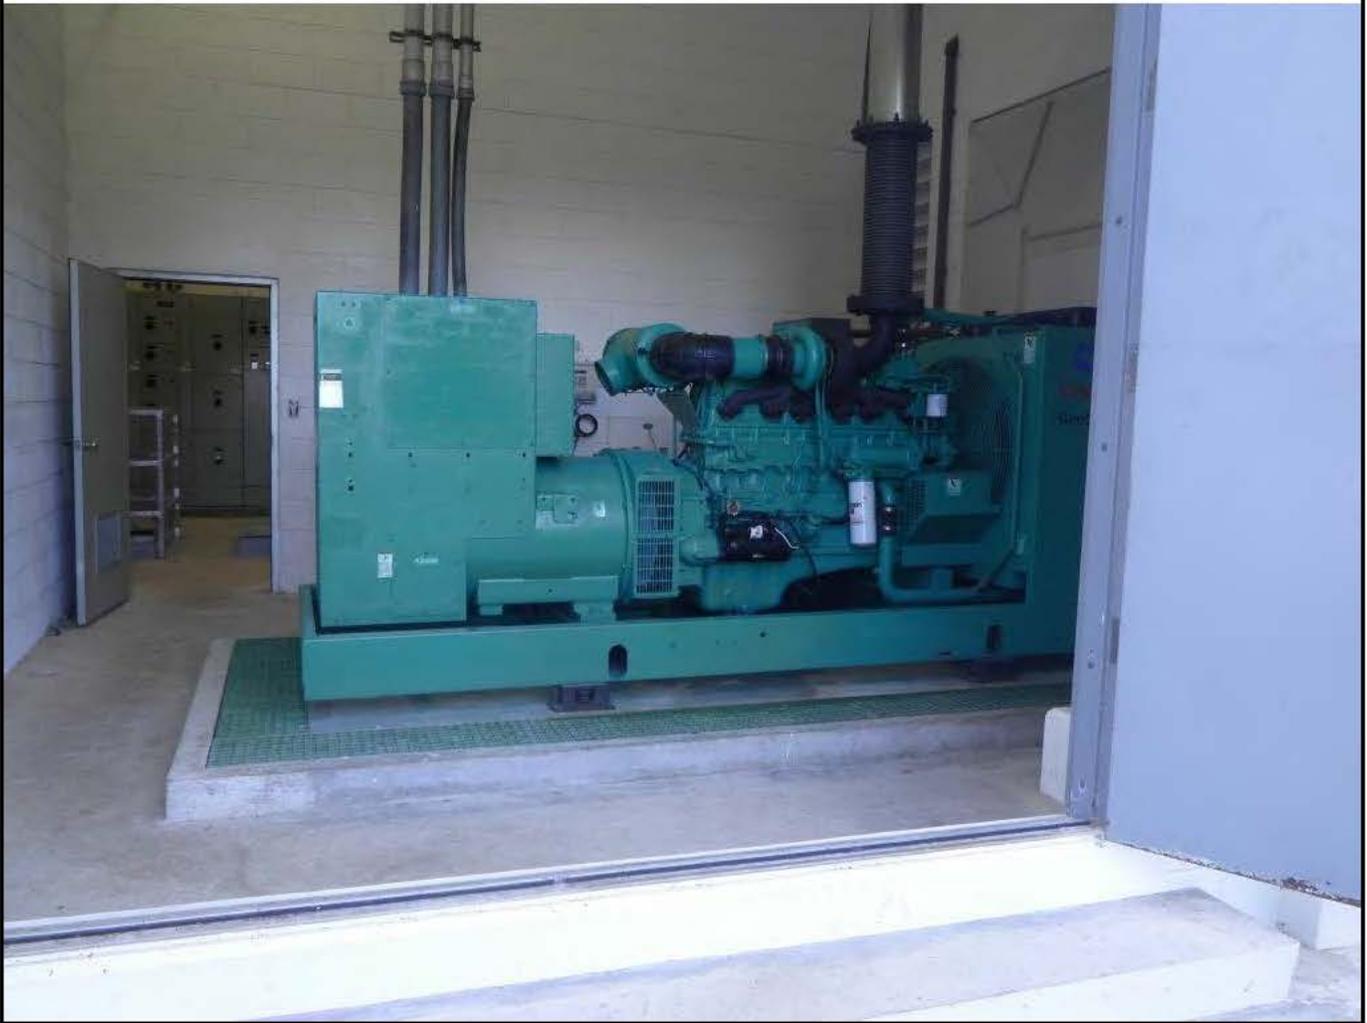
File Name: RIMG0001.JPG

Title	Guam Waterworks Authority (VP0989)
Subject	CWA Collection System
Latitude	[REDACTED]
Longitude	[REDACTED]
Photo Direction	[REDACTED]
Elevation	[REDACTED]
Date Time Stamp	4/25/2012 10:25:12 AM
Photographer	D. Vanlerberghe
Description	Chaligan pump station standby generator

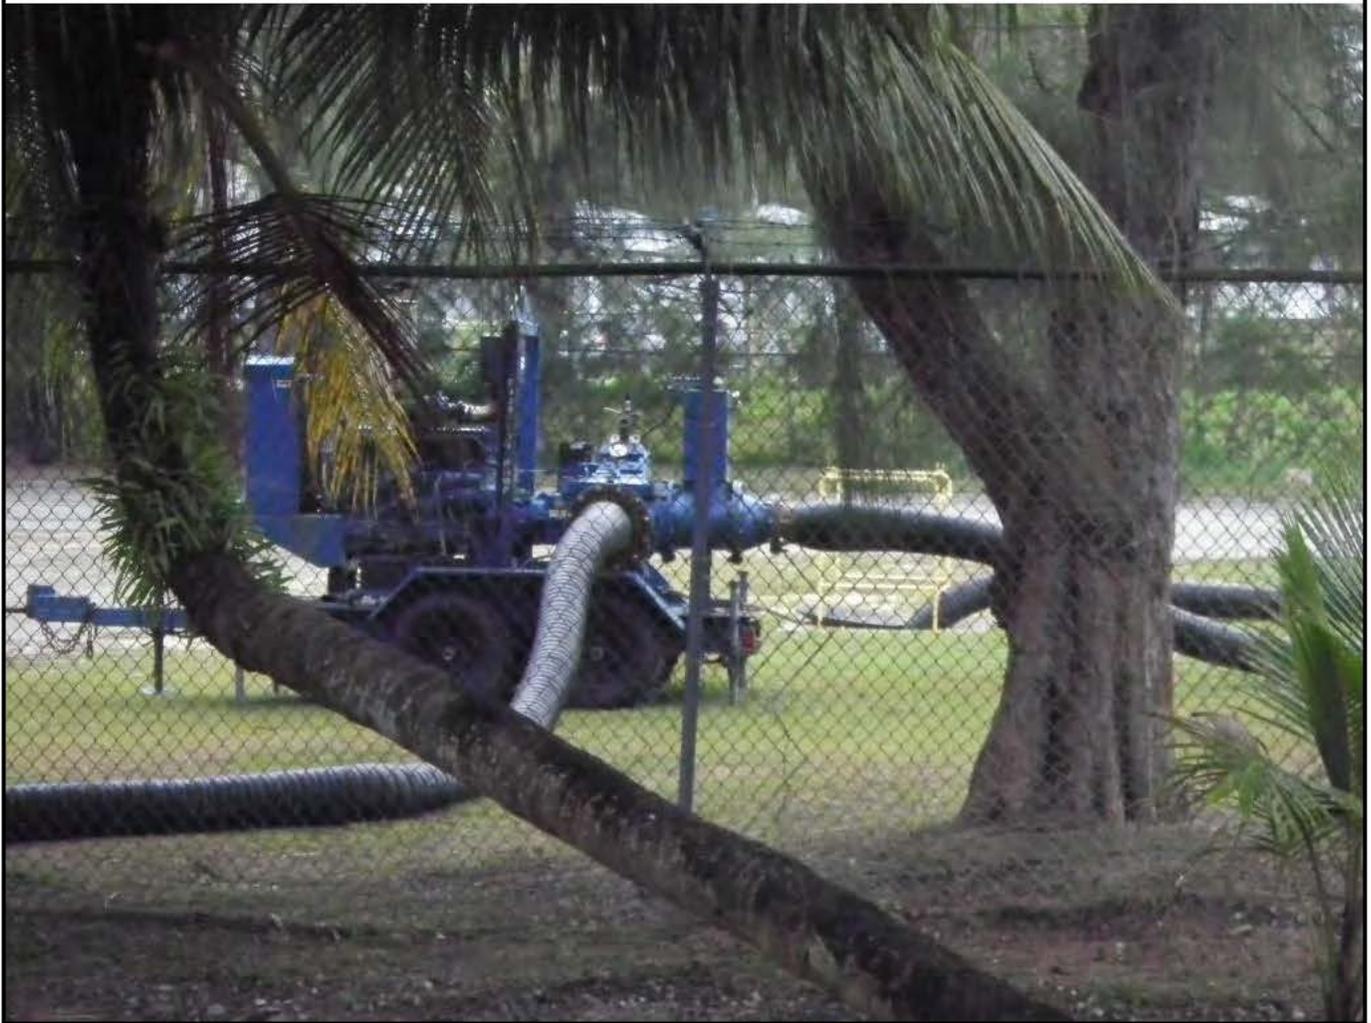
File Name: RIMG0004.JPG

Title	Guam Waterworks Authority (VP0989)
Subject	CWA Collection System
[REDACTED]	[REDACTED]
[REDACTED]	[REDACTED]
Date Time Stamp	4/25/2012 10:52:28 AM
Photographer	D. Vanlerberghe
Description	Agat WWTP influent manhole trash pump

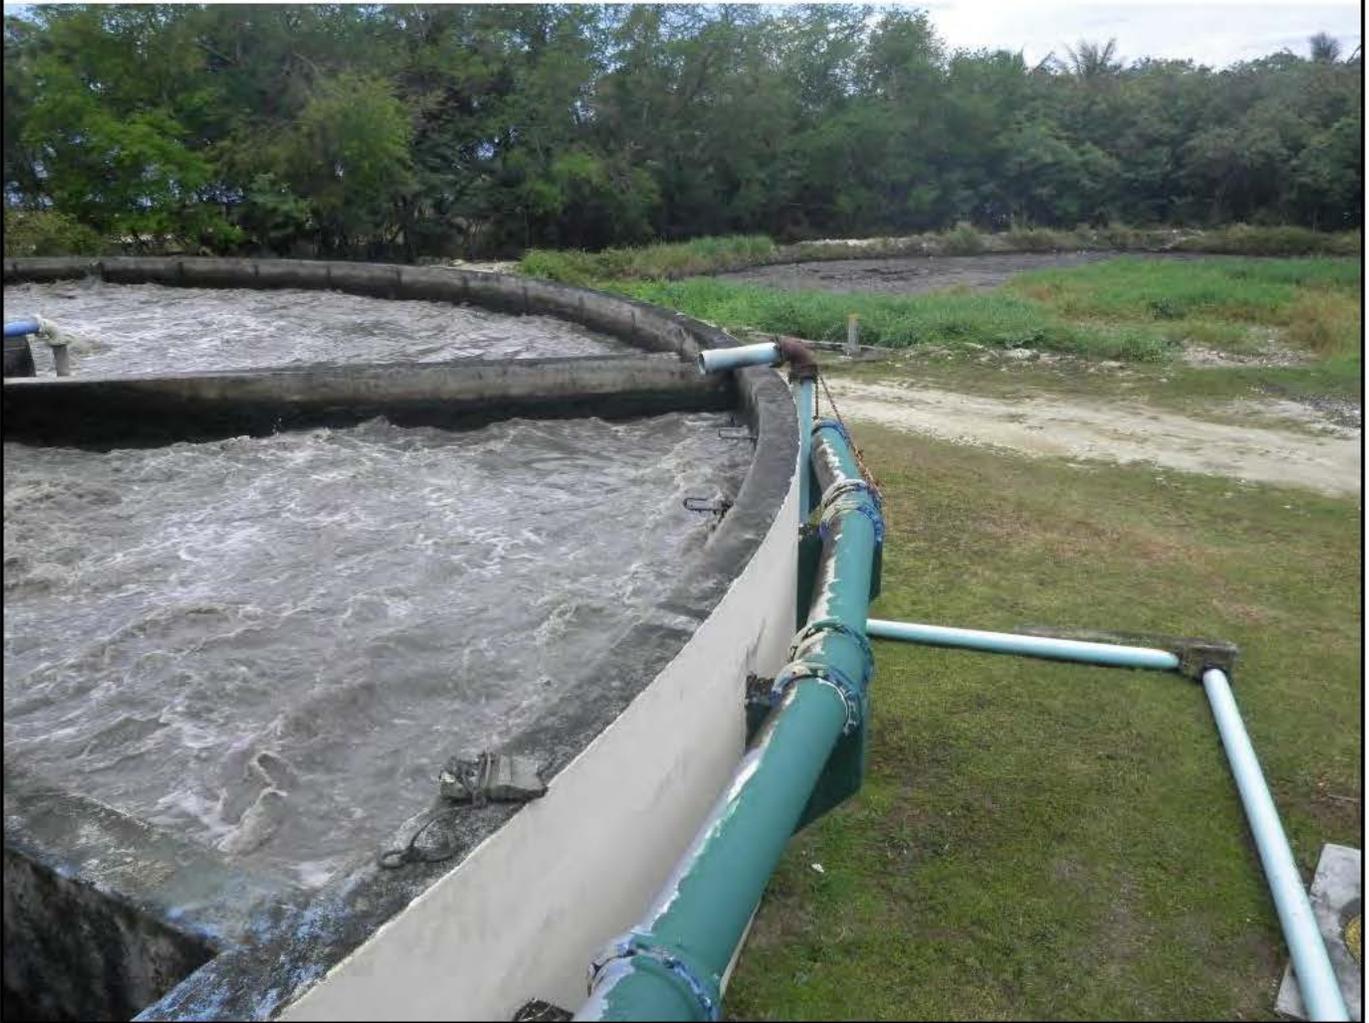
File Name: RIMG0005.JPG

Title	Guam Waterworks Authority (VP0989)
Subject	CWA Collection System
[REDACTED]	[REDACTED]
[REDACTED]	[REDACTED]
Date Time Stamp	4/25/2012 11:22:52 AM
Photographer	D. Vanlerberghe
Description	Trash pump pipeline into pre-aeration chamber at Agat WWTP

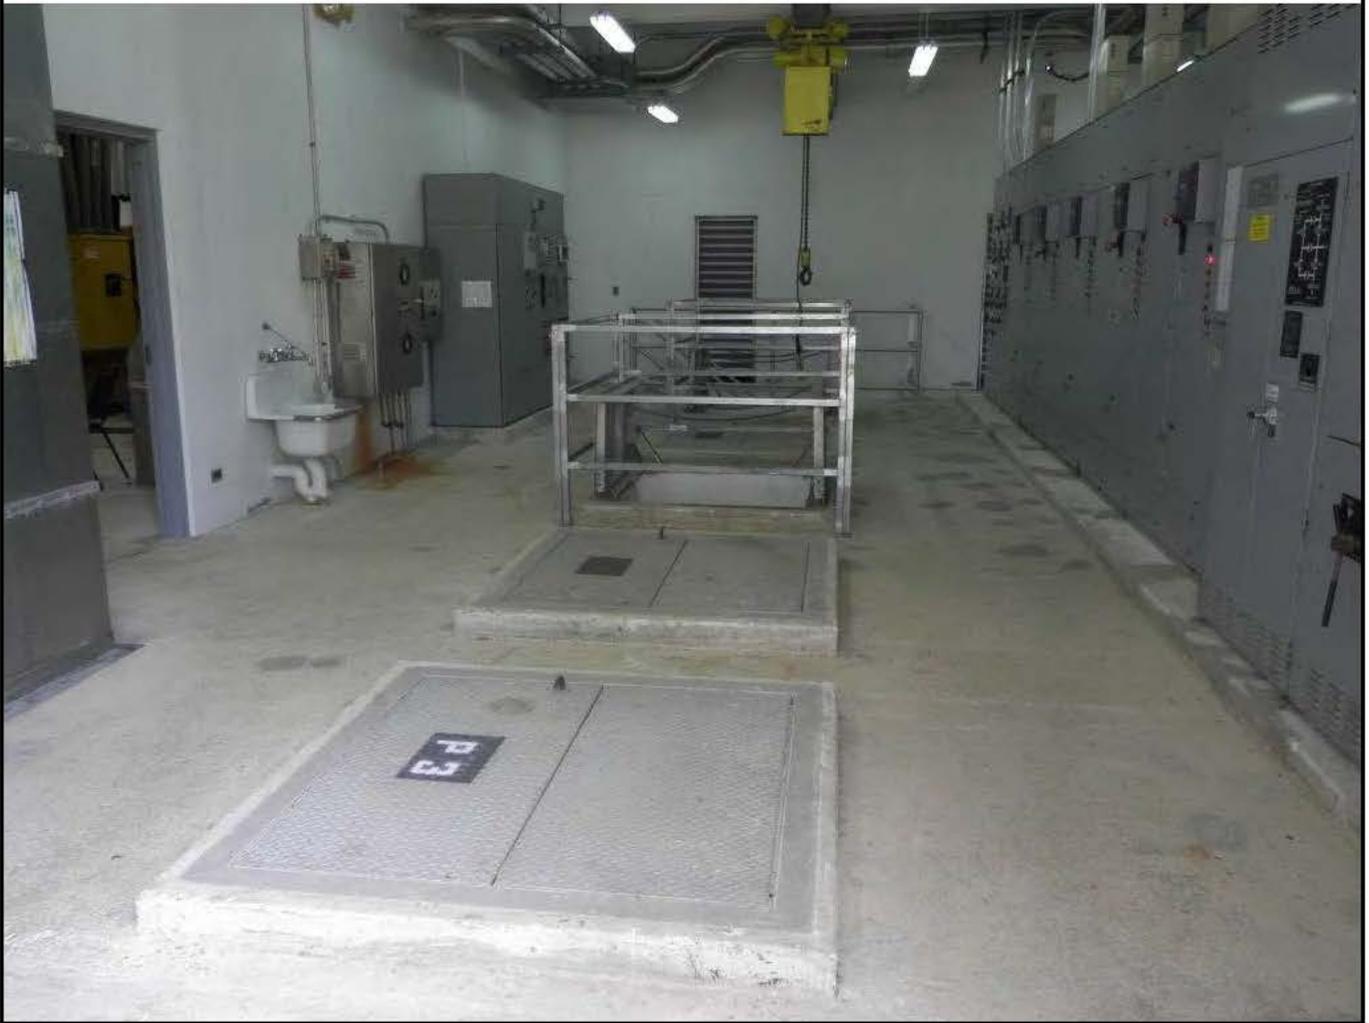
File Name: RIMG0007.JPG

Title	Guam Waterworks Authority (VP0989)
Subject	CWA Collection System
Date Time Stamp	4/25/2012 11:43:02 AM
Photographer	D. Vanlerberghe
Description	View inside Ga'an pump station building

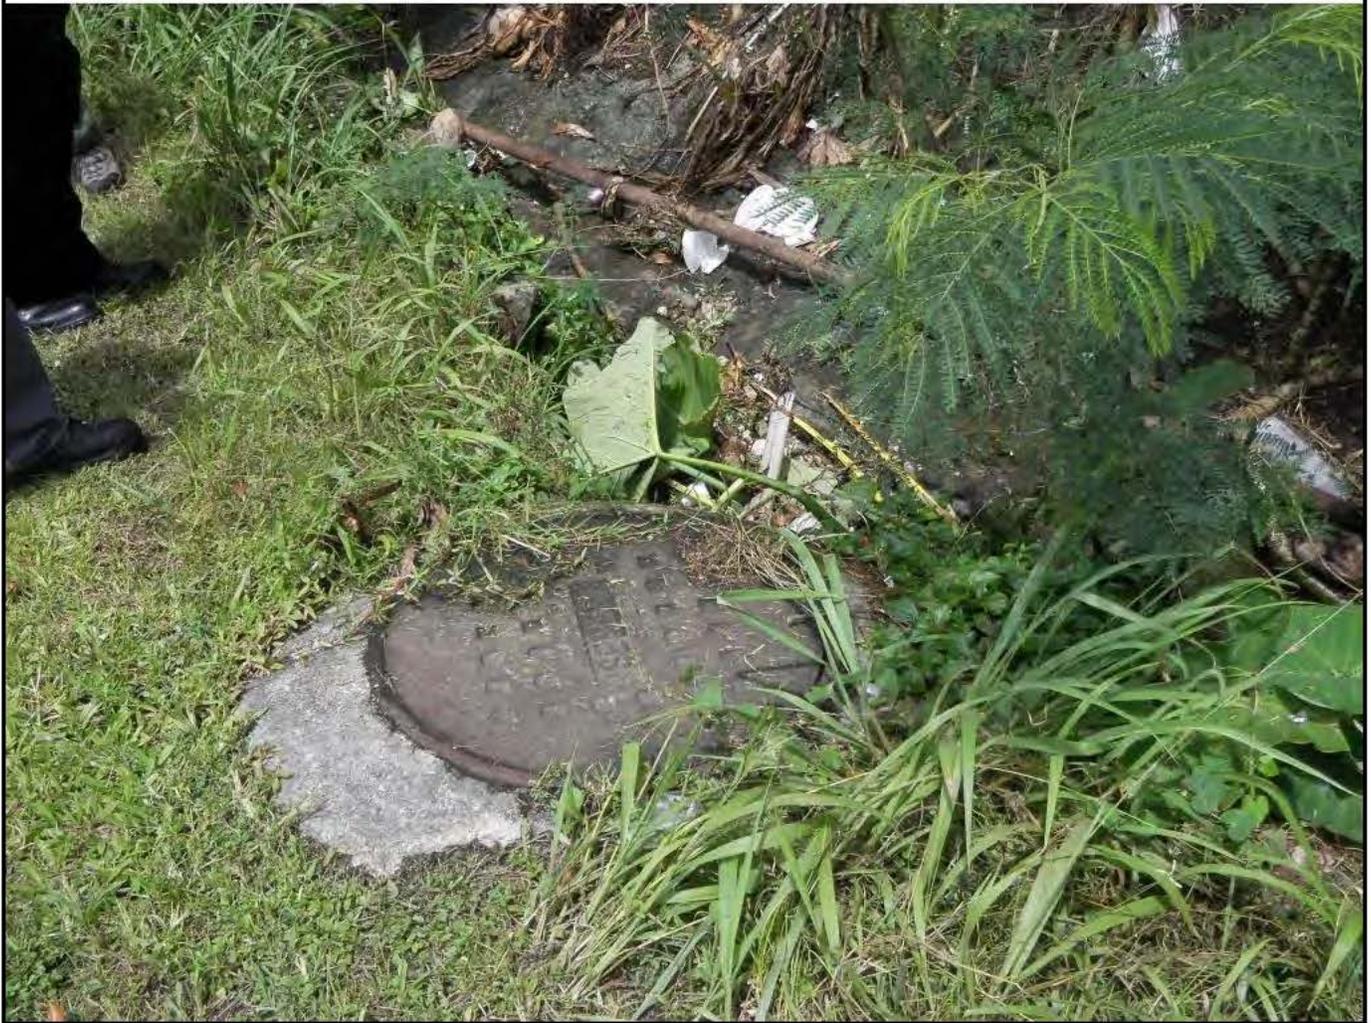
File Name: RIMG0013.JPG

Attributes	
Title	Guam Waterworks Authority (VP0989)
Subject	CWA Collection System
Date Time Stamp	4/25/2012 1:43:45 PM
Photographer	D. Vanlerberghe
Description	Second manhole near Merizo pump station No. 12, on east side of road near a roadside ditch, subject to potential direct inflow into sewer system.

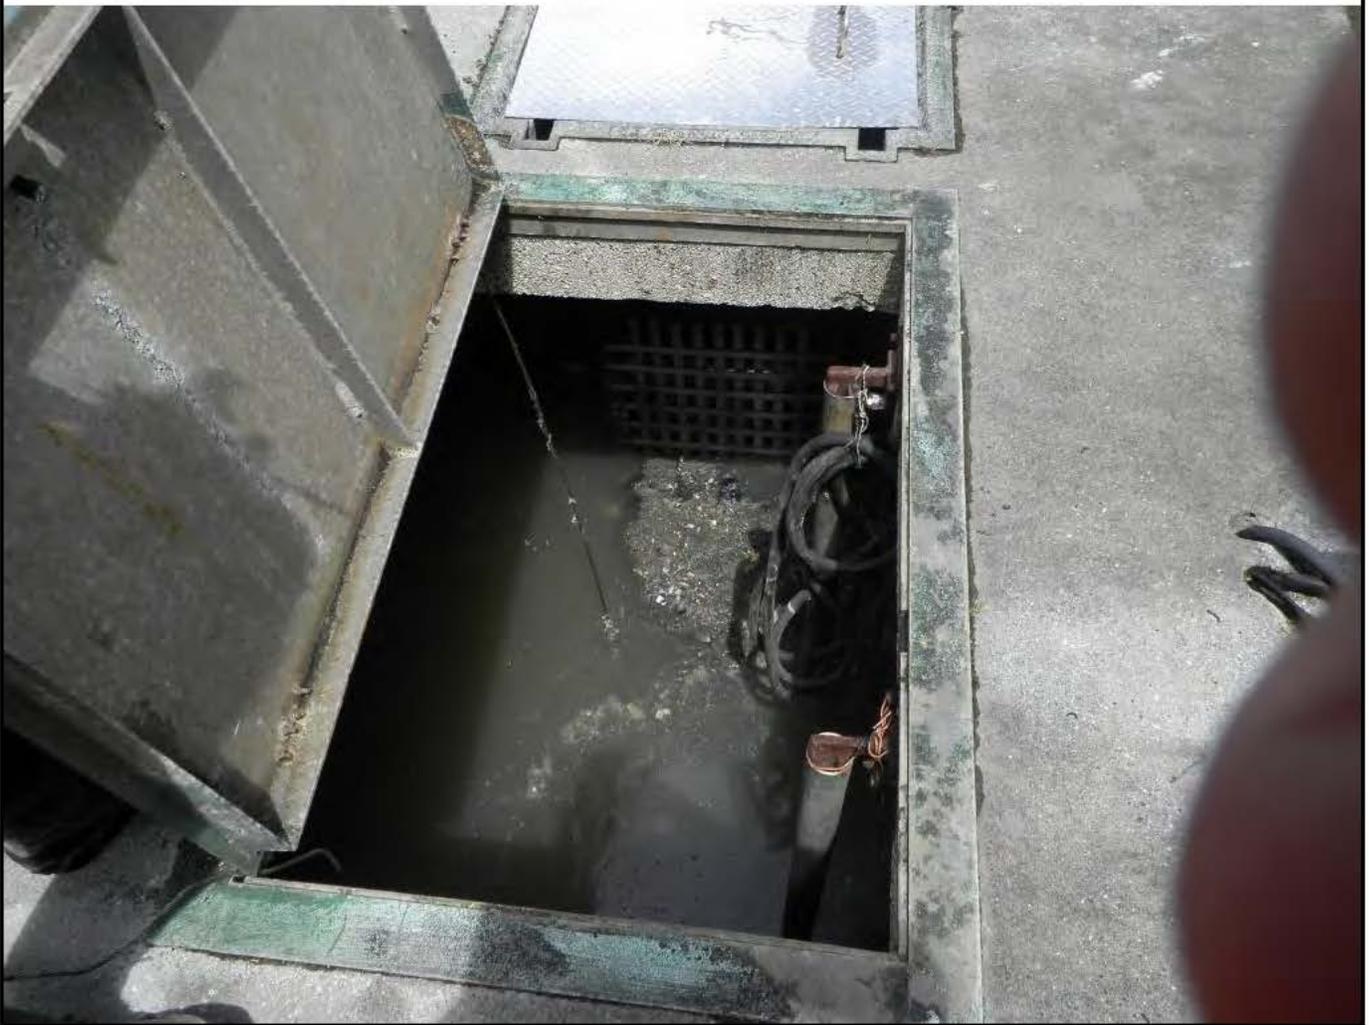
File Name: RIMG0015.JPG

Title	Guam Waterworks Authority (VP0989)
Subject	CWA Collection System
Date Time Stamp	4/25/2012 1:50:10 PM
Photographer	D. Vanlerberghe
Description	Merizo pump station No. 12 view inside wet well

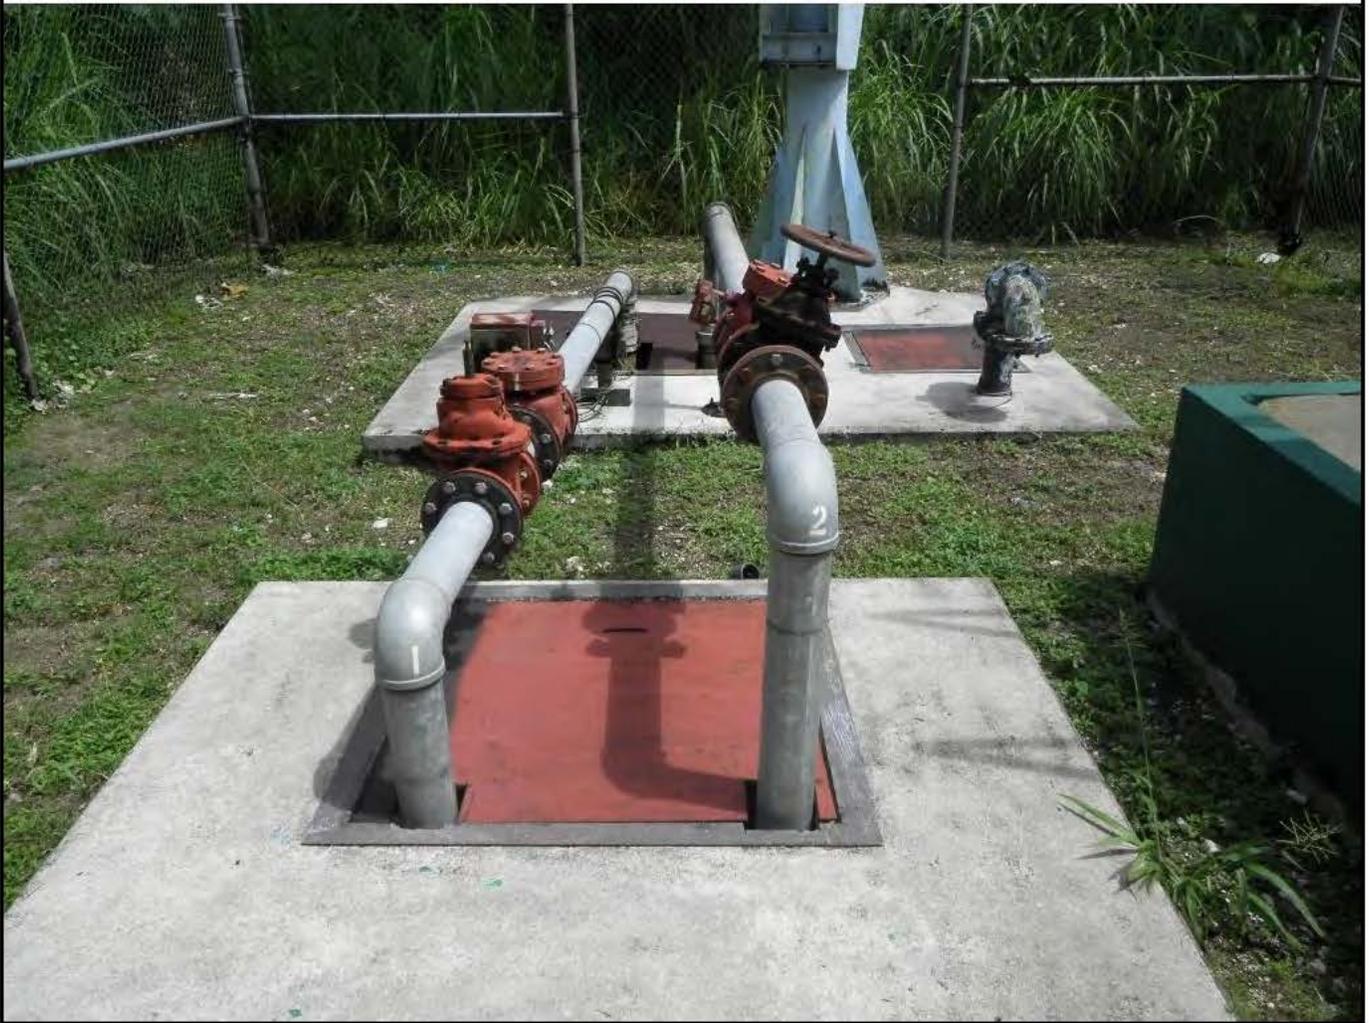
File Name: RIMG0017.JPG

Title	Guam Waterworks Authority (VP0989)
Subject	CWA Collection System
Date Time Stamp	4/25/2012 2:04:46 PM
Photographer	D. Vanlerberghe
Description	Merizo pump station No. 14 pump housing and wet well

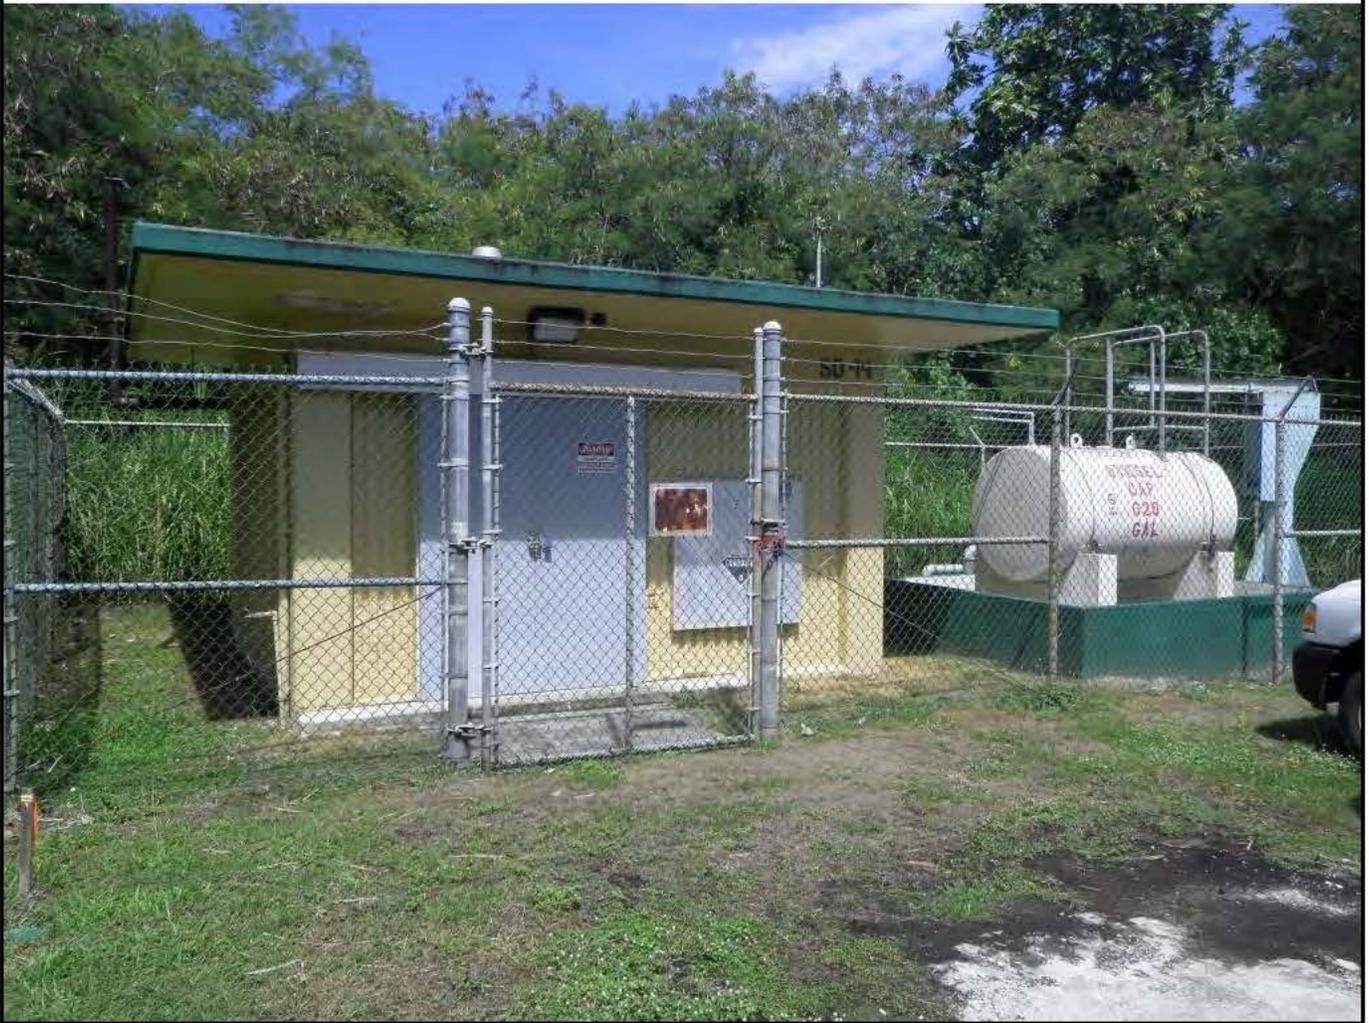
File Name: RIMG0018.JPG

Title	Guam Waterworks Authority (VP0989)
Subject	CWA Collection System
Date Time Stamp	4/25/2012 2:15:37 PM
Photographer	D. Vanlerberghe
Description	Merizo pump station No. 14 building

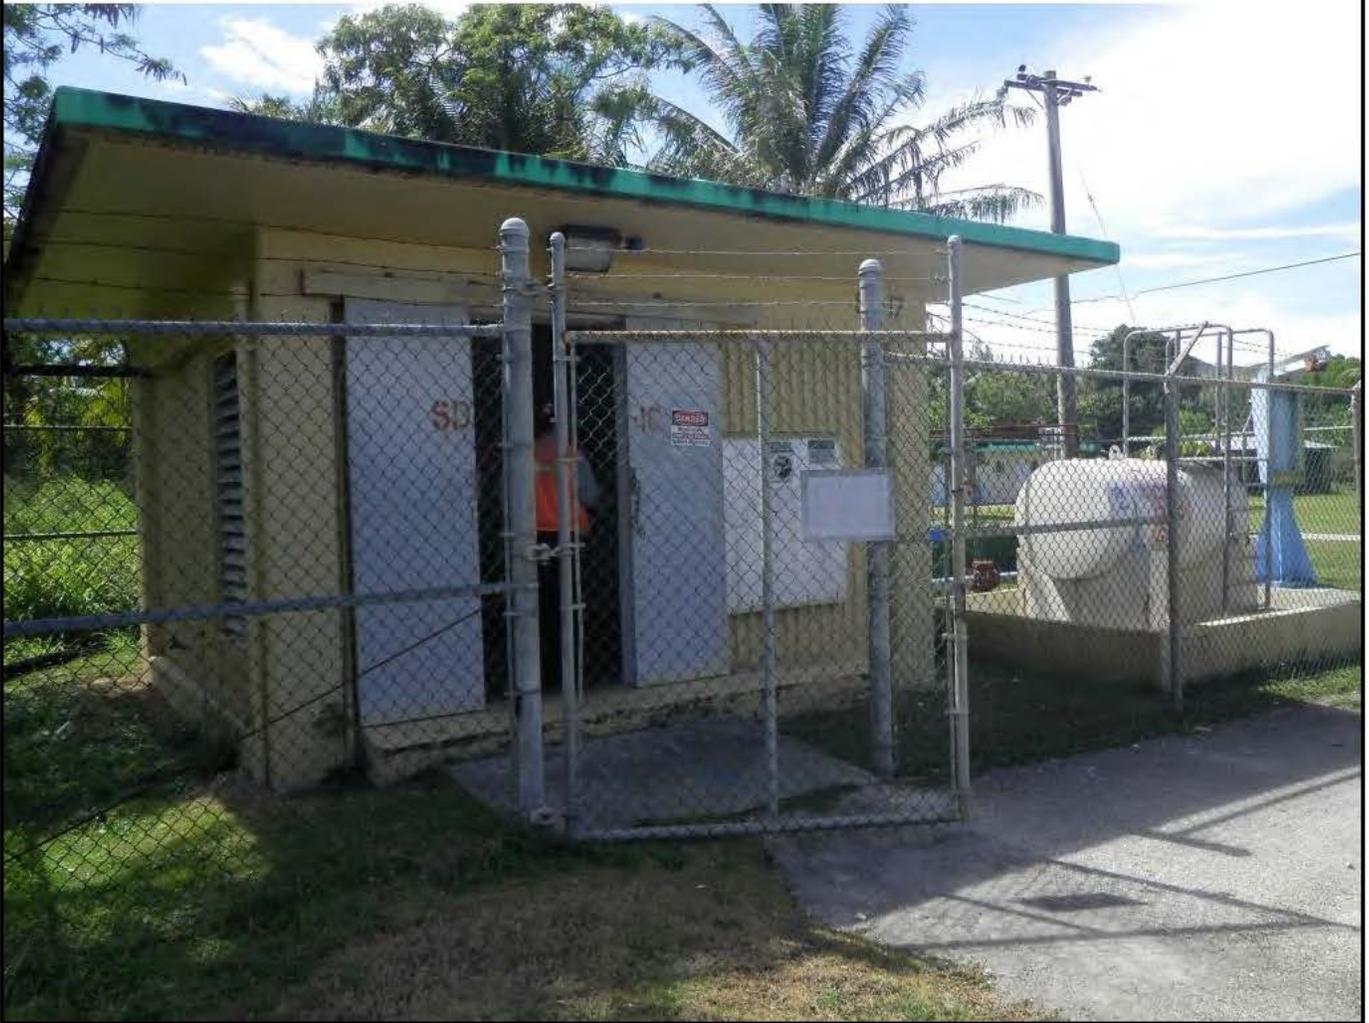
File Name: RIMG0019.JPG

Title	Guam Waterworks Authority (VP0989)
Subject	CWA Collection System
Date Time Stamp	4/25/2012 2:25:21 PM
Photographer	D. Vanlerberghe
Description	Merizo pump station No. 17 building

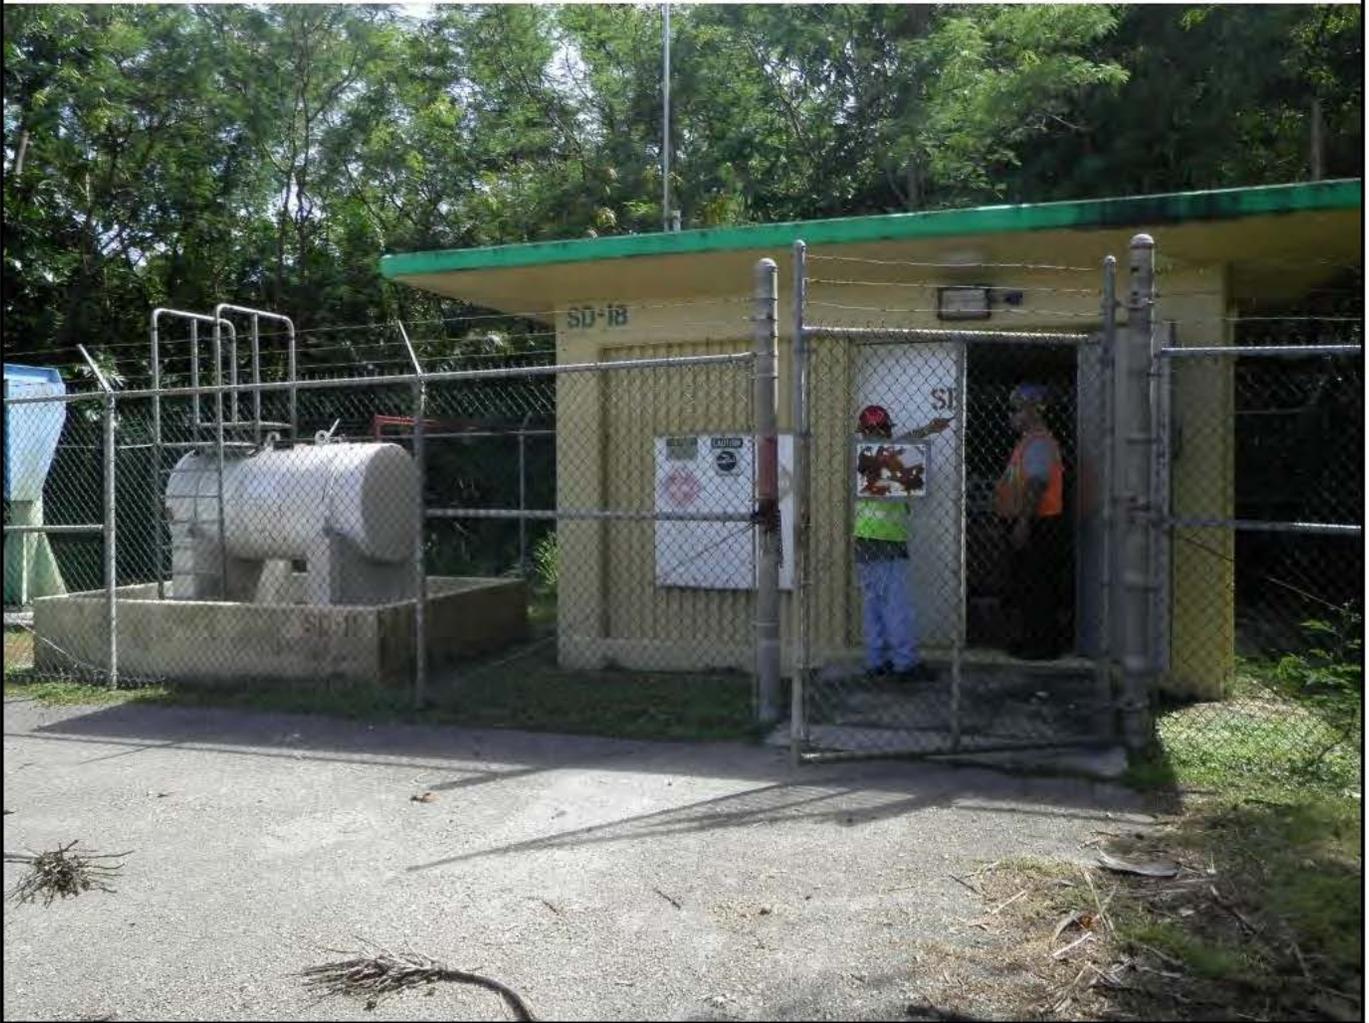
File Name: RIMG0021.JPG

Title	Guam Waterworks Authority (VP0989)
Subject	CWA Collection System
Date Time Stamp	4/25/2012 2:44:49 PM
Photographer	D. Vanlerberghe
Description	Merizo pump station No. 18 building

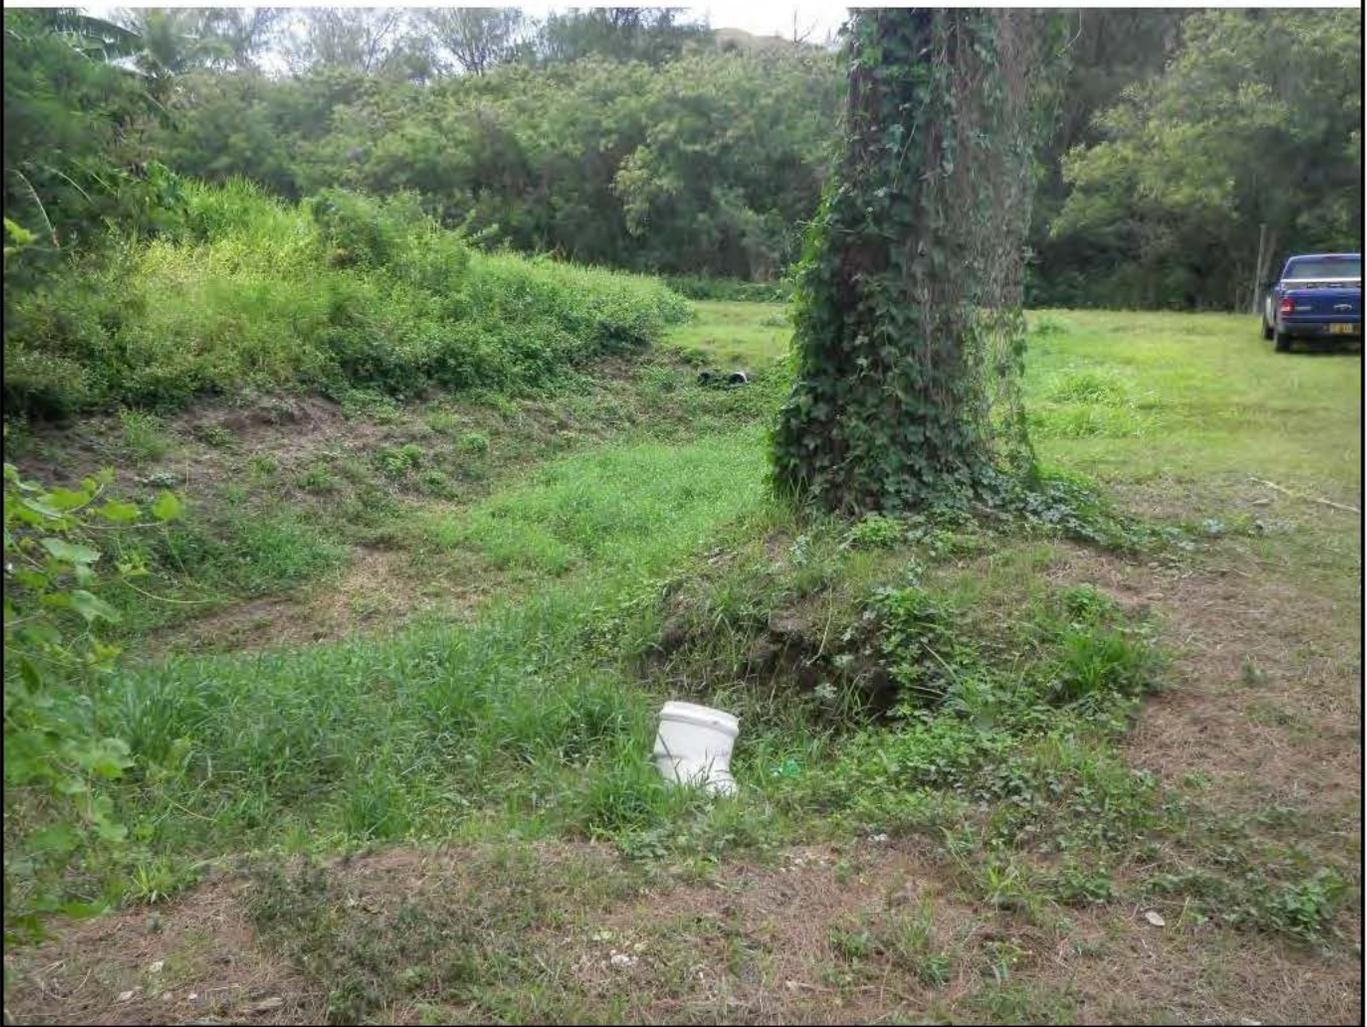
File Name: RIMG0026.JPG

Attributes	
Title	Guam Waterworks Authority (VP0989)
Subject	CWA Collection System
Date Time Stamp	4/26/2012 10:20:34 AM
Photographer	D. Vanlerberghe
Description	Emergency overflow pipe from lagoon at Umatac WWTP

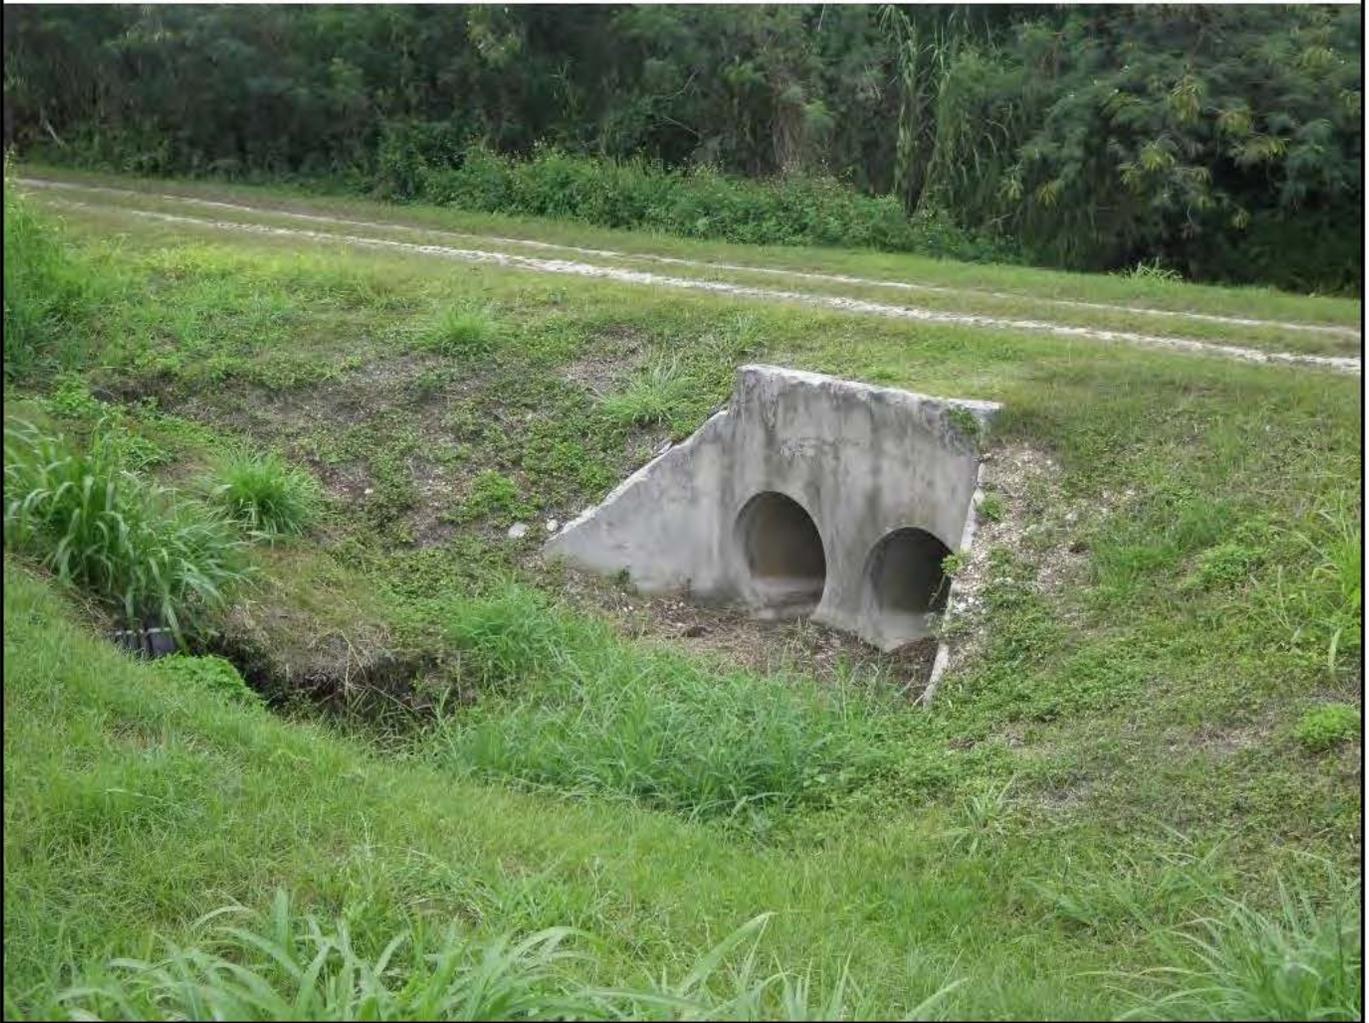
File Name: RIMG0028.JPG

<b>Title</b>	Guam Waterworks Authority (VP0989)
<b>Subject</b>	CWA Collection System
<b>Date Time Stamp</b>	4/26/2012 10:26:11 AM
<b>Photographer</b>	D. Vanlerberghe
<b>Description</b>	Outlet from emergency overflow from lagoon at Umatac WWTP, pipes to unnamed stream in background

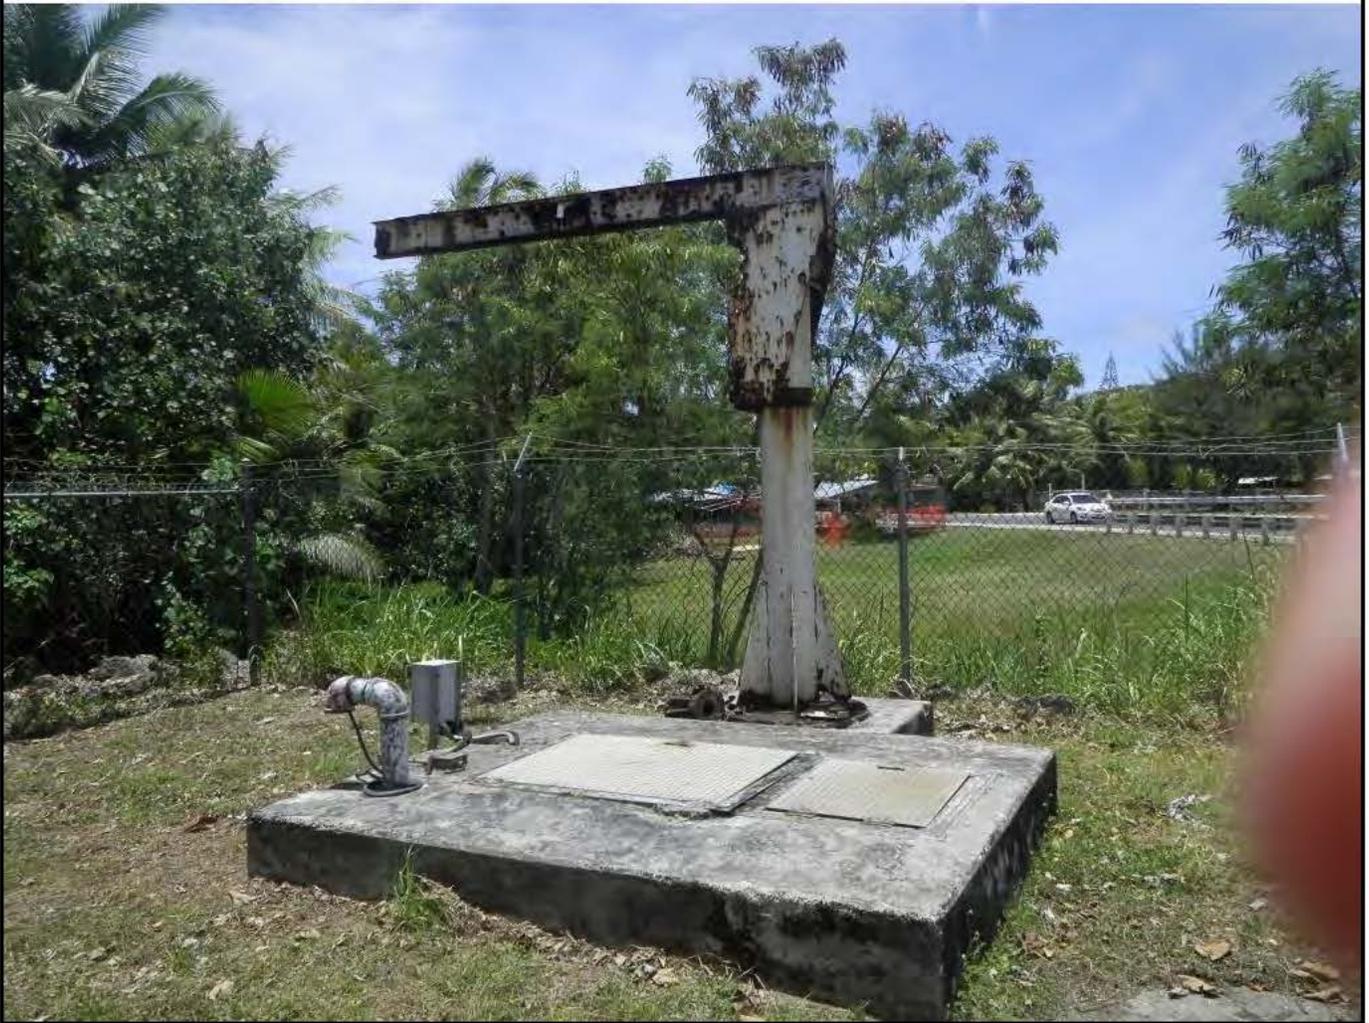
File Name: RIMG0035.JPG

Title	Guam Waterworks Authority (VP0989)
Subject	CWA Collection System
Date Time Stamp	4/26/2012 12:08:20 PM
Photographer	D. Vanlerberghe
Description	Inarajan lift pump station pump housing and wet well

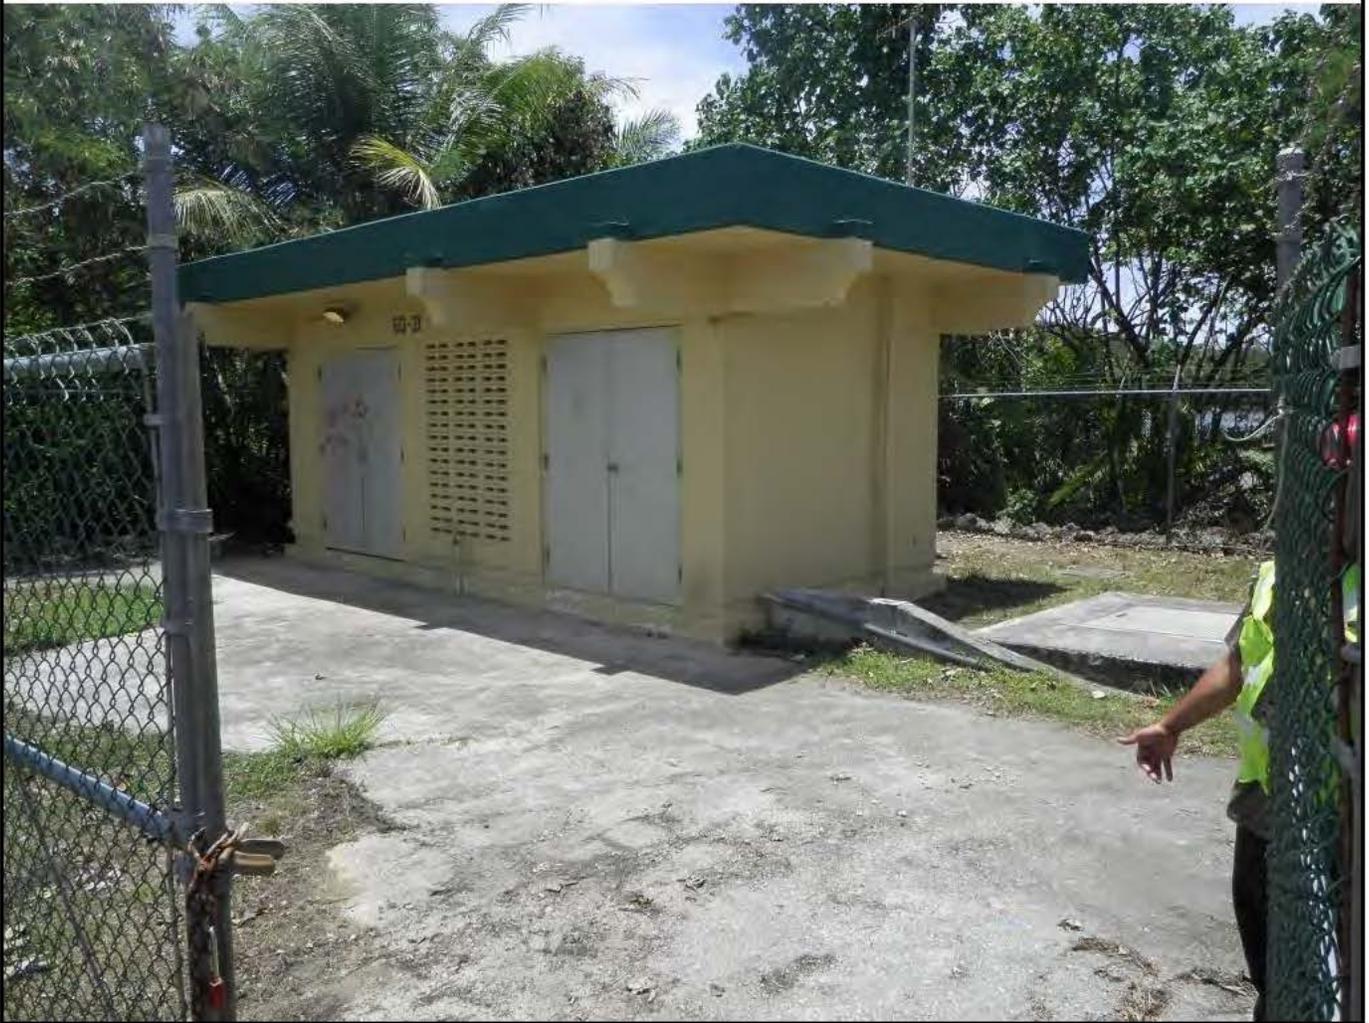
File Name: RIMG0036.JPG

Title	Guam Waterworks Authority (VP0989)
Subject	CWA Collection System
[REDACTED]	[REDACTED]
[REDACTED]	[REDACTED]
Date Time Stamp	4/26/2012 12:11:47 PM
Photographer	D. Vanlerberghe
Description	Inarajan lift pump station building

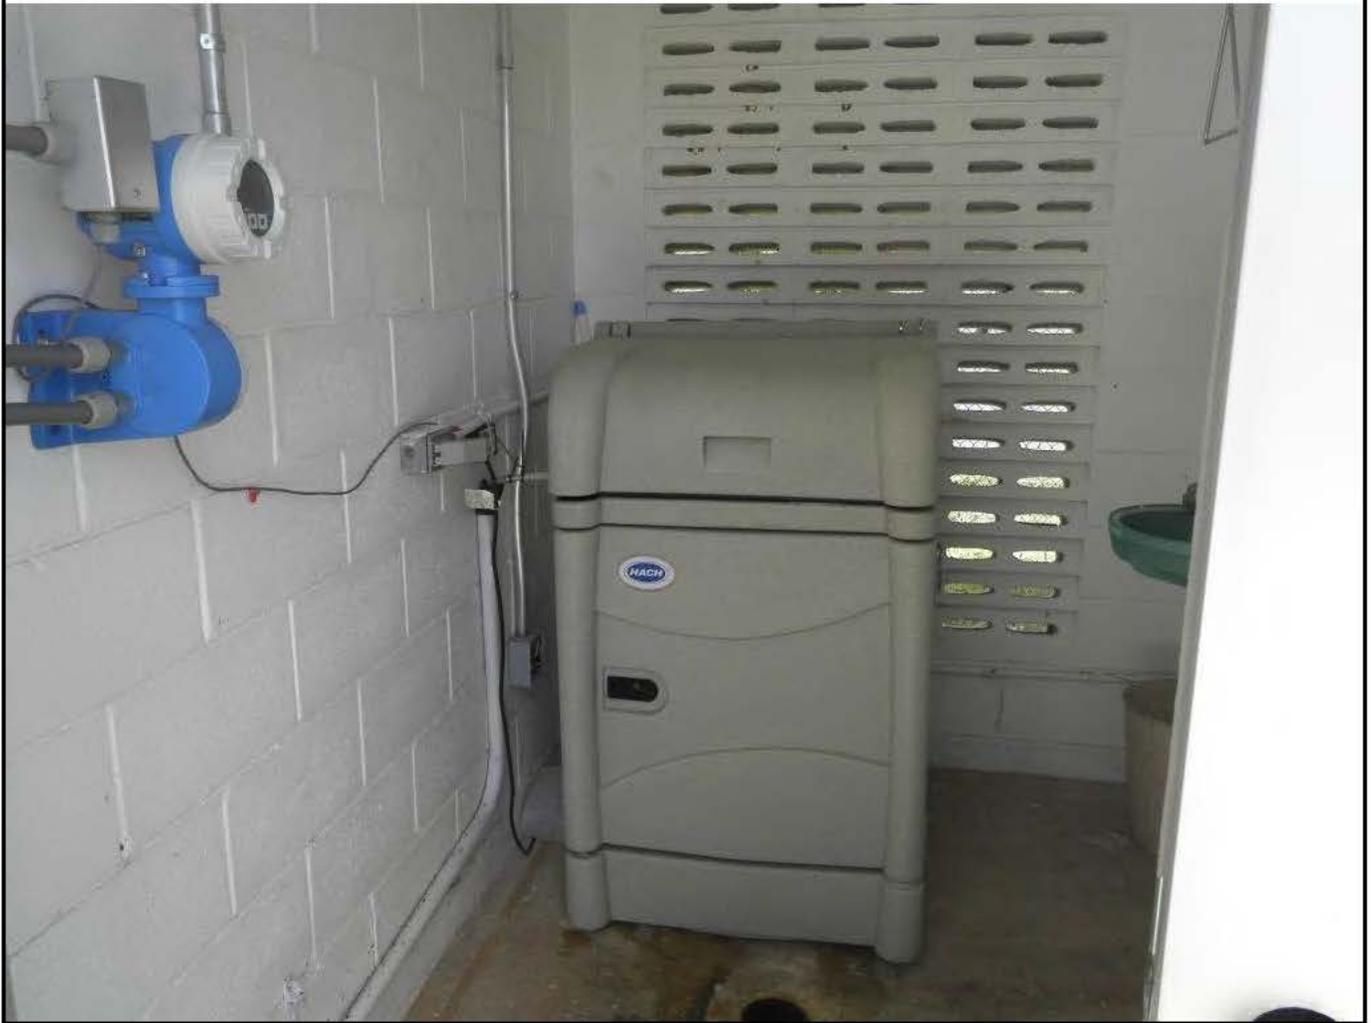
File Name: RIMG0037.JPG

Title	Guam Waterworks Authority (VP0989)
Subject	CWA Collection System
Date Time Stamp	4/26/2012 12:20:50 PM
Photographer	D. Vanlerberghe
Description	Sampling equipment at Inarajan main pump station, including flow meter totalizer and automatic sampler
